Sweden's droughts 2016-2018 actions taken and lessons learned -Groundwater

2018-11-08

Sveriges geologiska undersökning
Geological Survey of Sweden

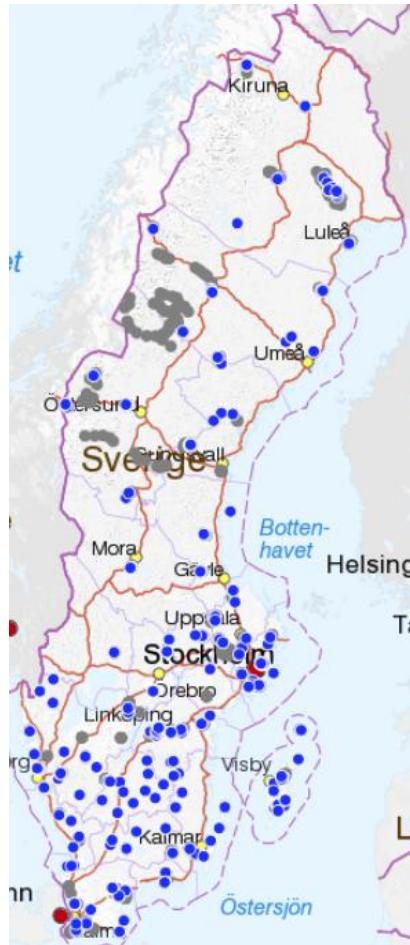
Monitoring of groundwater levels

Started 1966

At present: About 300 sites

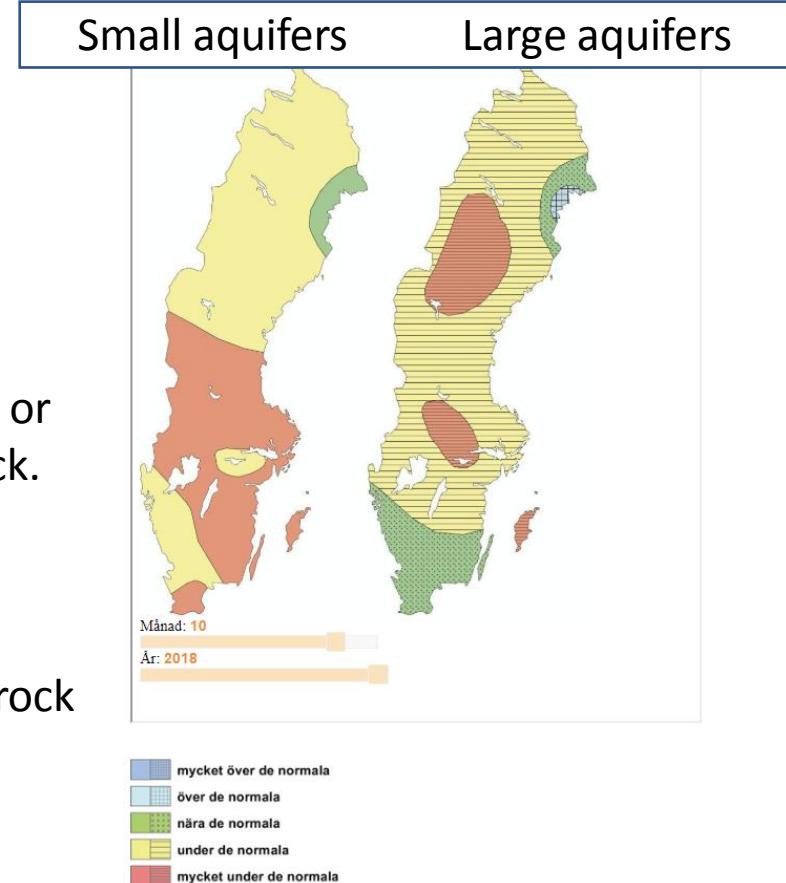
Small aquifers:
Usually glacial till or
crystalline bedrock.

Large aquifers:
Usually eskers or
sedimentary bedrock

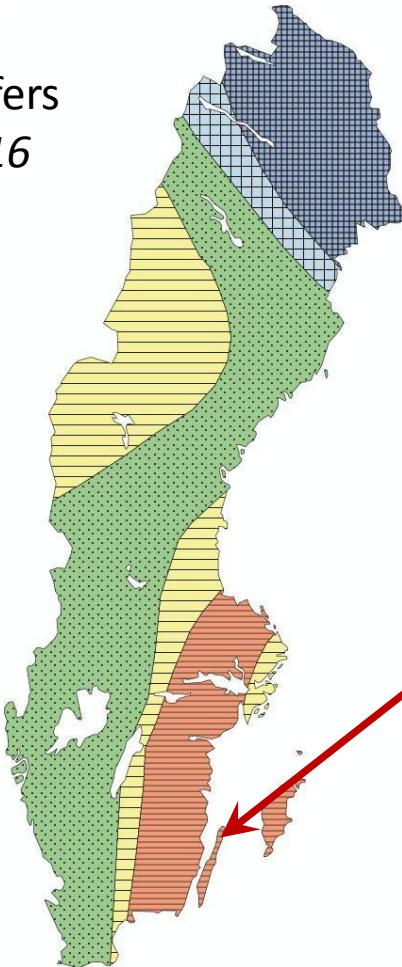
Extremely low groundwater levels 2016 – Large aquifers

Large aquifers
August 2016

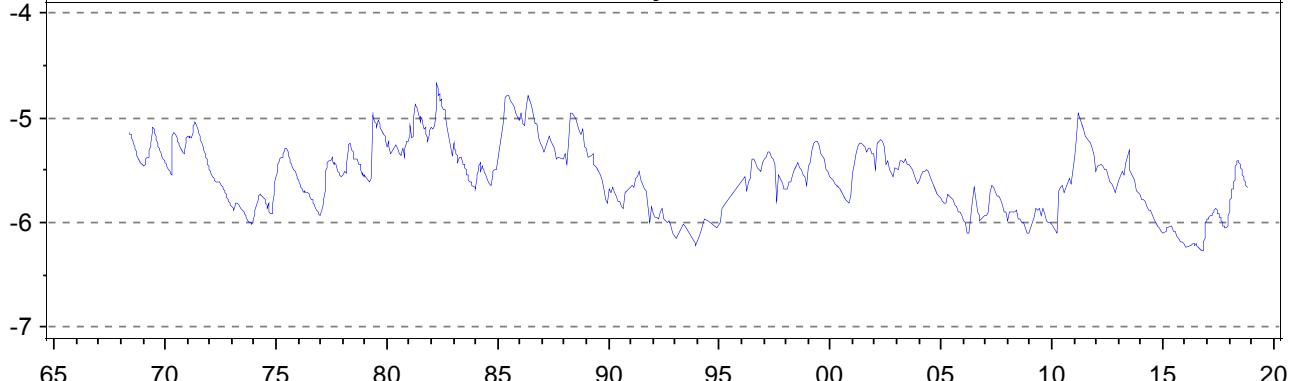
SGU, Grundvattennätet, Böda, station 7:9
Grundvattennivåer, meter under markytan

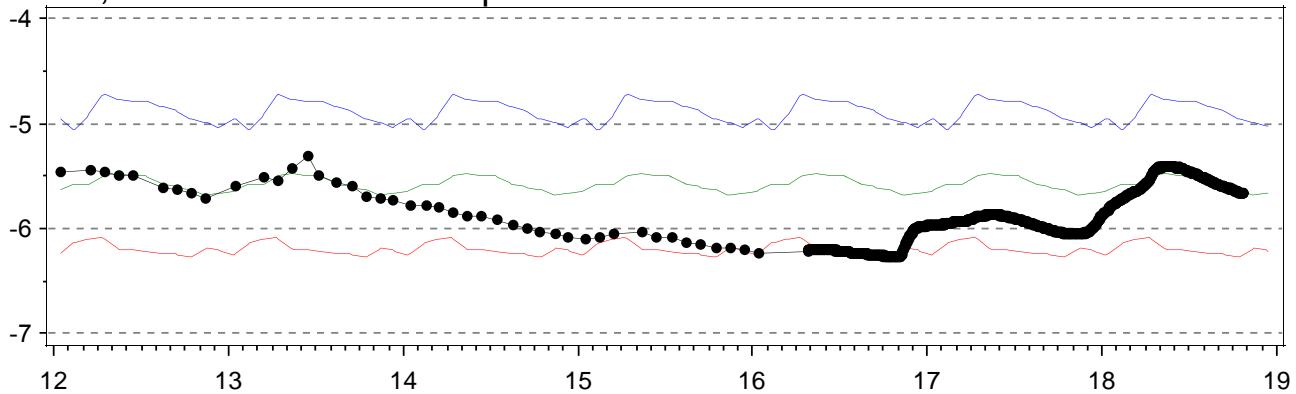
SGU, Grundvattennätet, Böda, Område 7, Station 9
Min, medel och max avser perioden 1970 - 2017

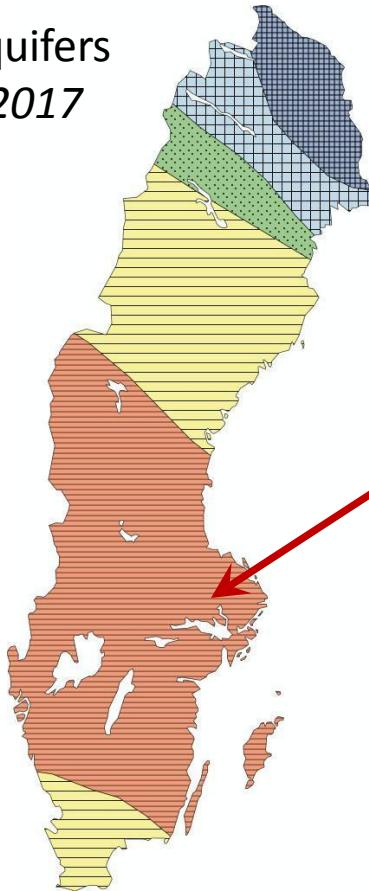
Extremely low groundwater levels 2017 – Large aquifers

Large aquifers
August 2017

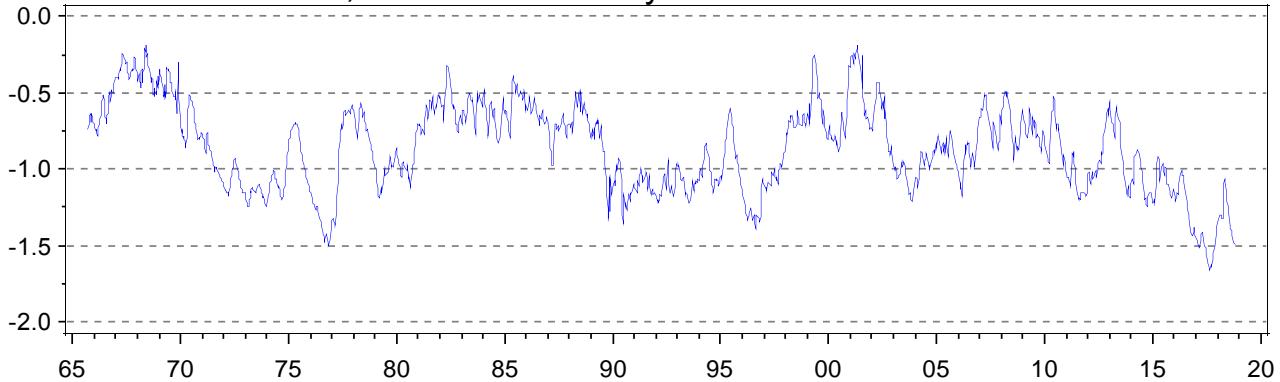
SGU, Grundvattennätet, Sala, station 20:1
Grundvattennivåer, meter under markytan

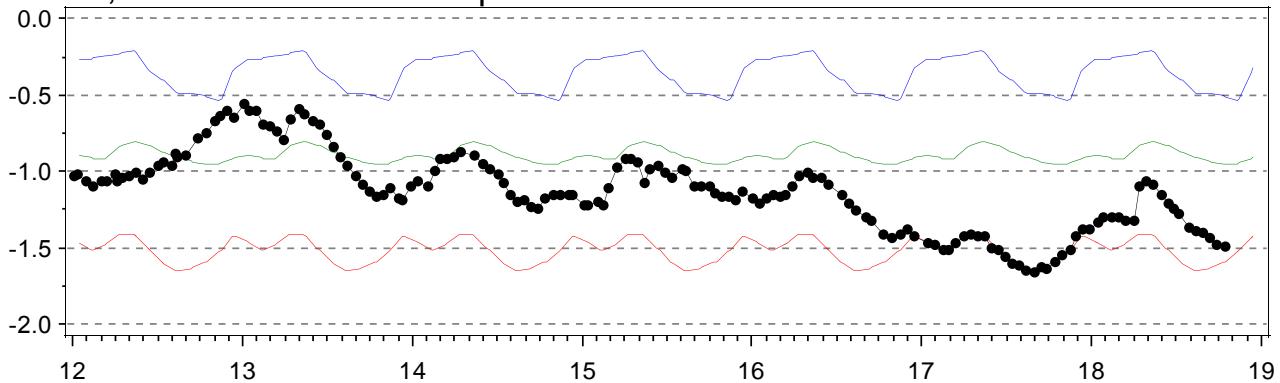
SGU, Grundvattennätet, Sala, Område 20, Station 1
Min, medel och max avser perioden 1970 - 2017

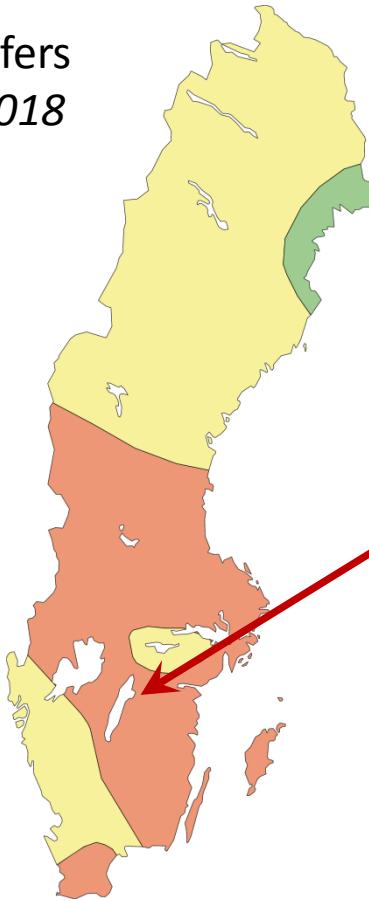
Extremely low groundwater levels 2018 – small aquifers

Small aquifers
October 2018

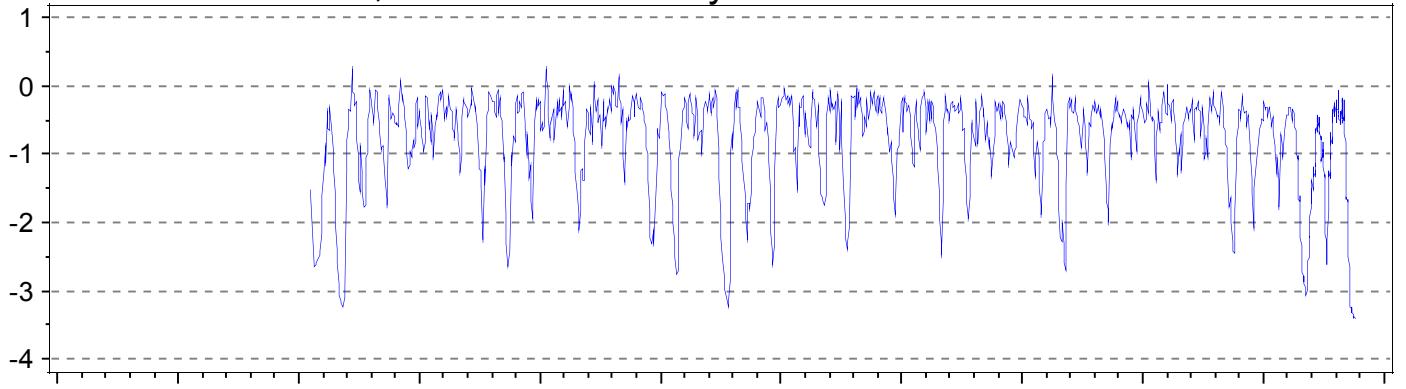
SGU, Grundvattennätet, Motala, station 60:46
Grundvattennivåer, meter under markytan

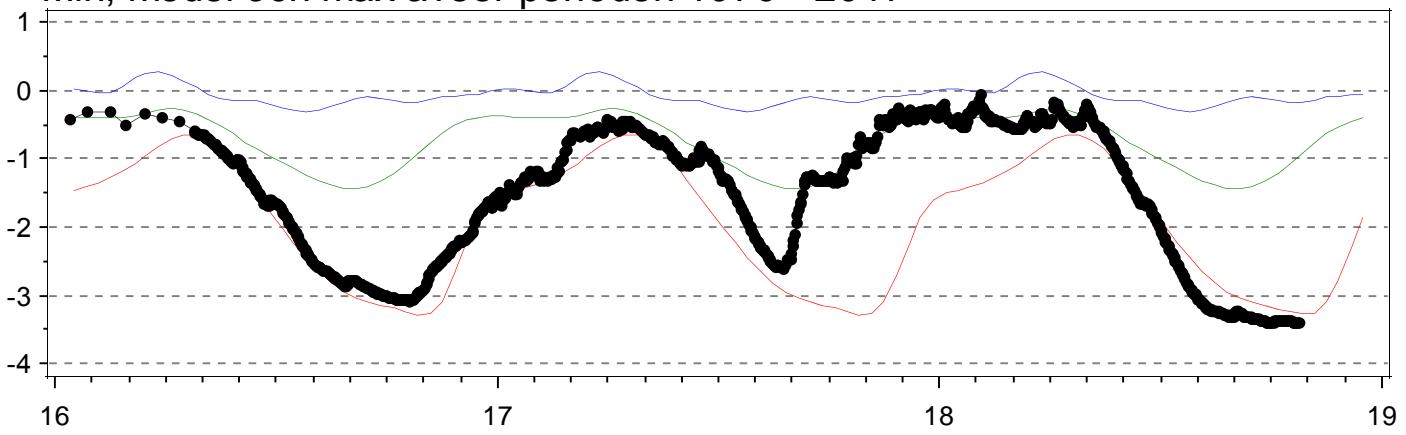
SGU, Grundvattennätet, Motala, Område 60, Station 46
Min, medel och max avser perioden 1976 - 2017

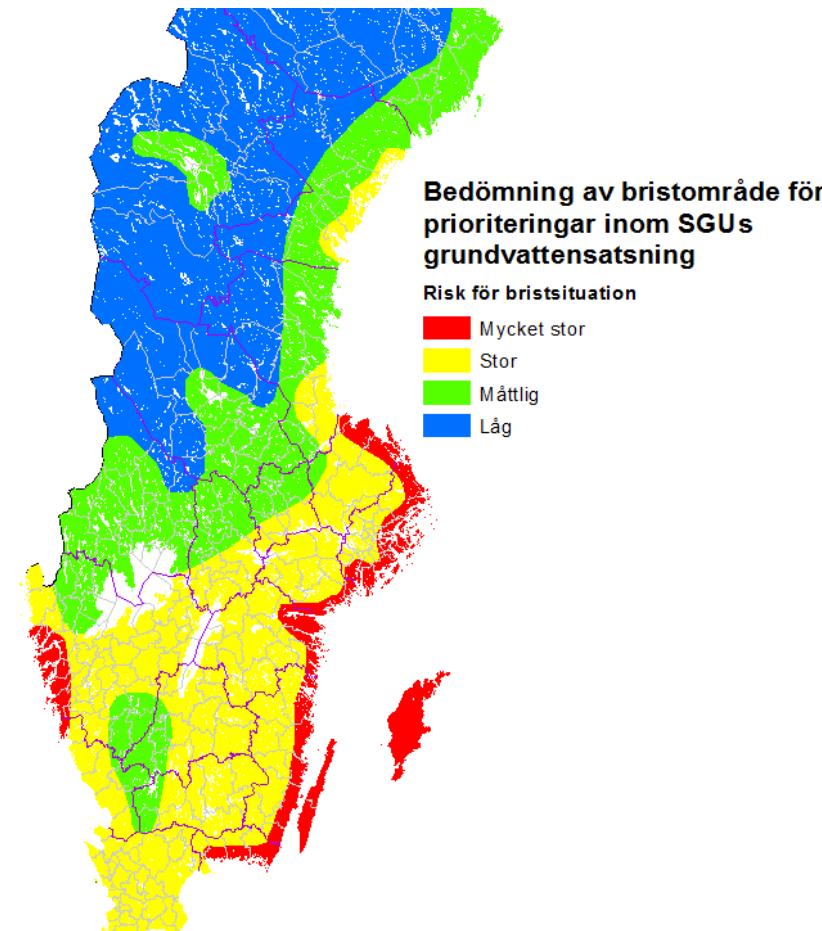
Areas with increased risk that
access to groundwater does not meet the needs of
groundwater.
